WORLD SAILING INVESTIGATION REPORT NACRA 17 INCIDENT

Prepared by: Kowalyshyn, Dina
Equipment Committee Chair

REVIEW OF NACRA 17 CLASS INCIDENT WITH SEVERE INJURY TO HAND

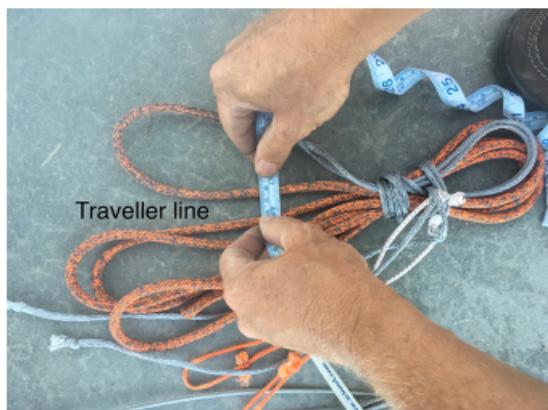
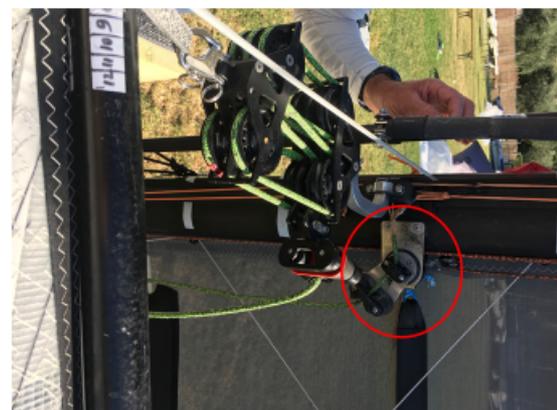
Traveler Arrangement – 6mm control line

- iv. The helm has identified the traveler line wrapped around his right hand as the mechanism of the injury. In watching the video it can be seen that the main is on centerline until second 0:55 of the video when it suddenly drops to leeward. The sailors are not visible at this angle but this tells us that the traveler line has come loose and we know both sailors are forward in the water.

- a. Personal Safety Awareness – Wrapping lines around the hand should be discouraged. This lesson is taught in learn to sail and must be reinforced as the sailor's progress into higher performance boats.

- b. Personal Safety should inform the design of the boat's rigging and controls. Controls allowed in the class rules should have sufficient purchase to allow a high-performance sailor to hold the line without wrapping it around a hand. It is beyond the scope of this investigation to assign that force.

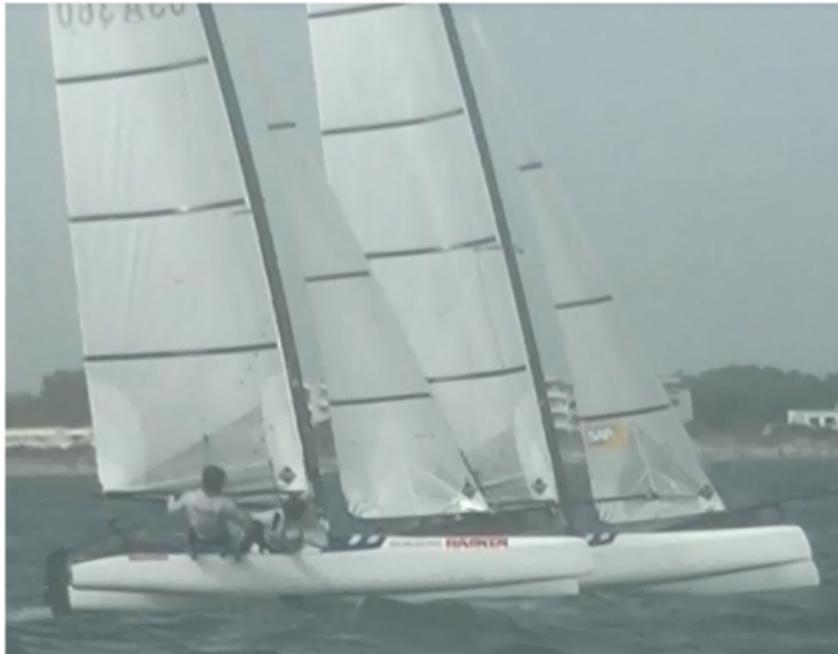
Figure D1 - Prior to Windward Mark

Accident occurred at the bear away after rounding the windward mark, as the boat turns at the offset mark.

Pictured:
Approaching the Windward Mark –
Note sailors positions, trapezing side by side with crew straddling the Shroud.

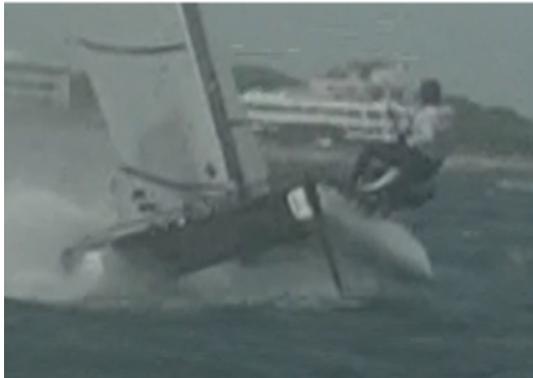
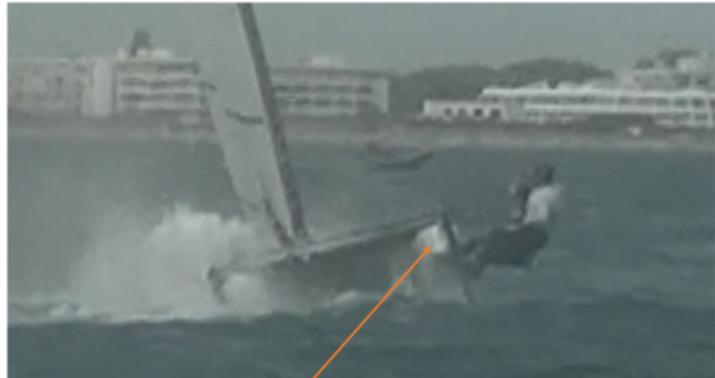
Figure D2 - Early in the Pitchpole

- b. The video shows that the leeward hull drops and digs into the water to initiate the pitchpole right at the offset mark. That action would be caused by an unbalancing of the boat at that time. The forces on the mainsail change as the mainsail controls are being eased as stated by the crew, increasing the force on the mainsail and moving the center of effort forward, and possibly up. This would cause a greater downward force on the leeward hull, and cause the bow down attitude the boat takes as it digs in and pivots around the leeward bow during the pitchpole. The helm is not clear on whether he moved the tiller to bearaway but it is assumed that he did. This also contributes to creating an unbalance in the boat.

Bearing away and going bow down

Both sailors still standing on side of hull, not under hull

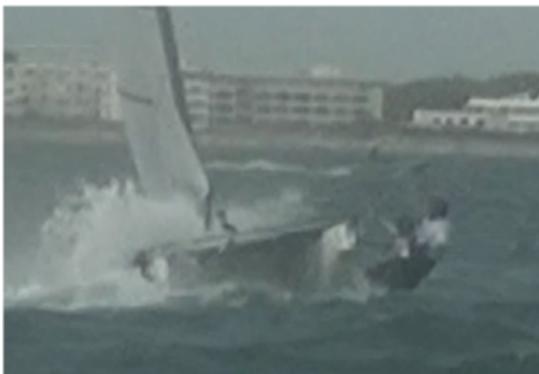
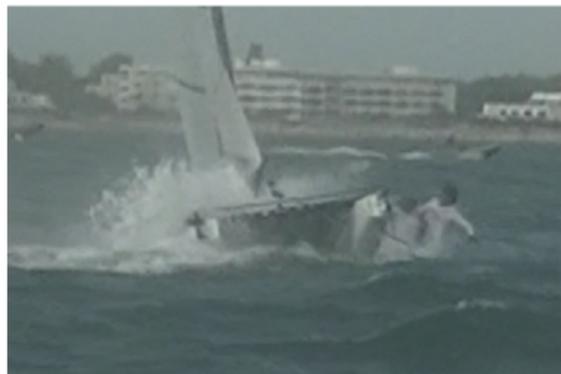
Figure D3 - Next Frames

These freeze frames begin at 0:53 of the video

Sailors still above the water, far away from hull

Looks like skipper is now outside of crew

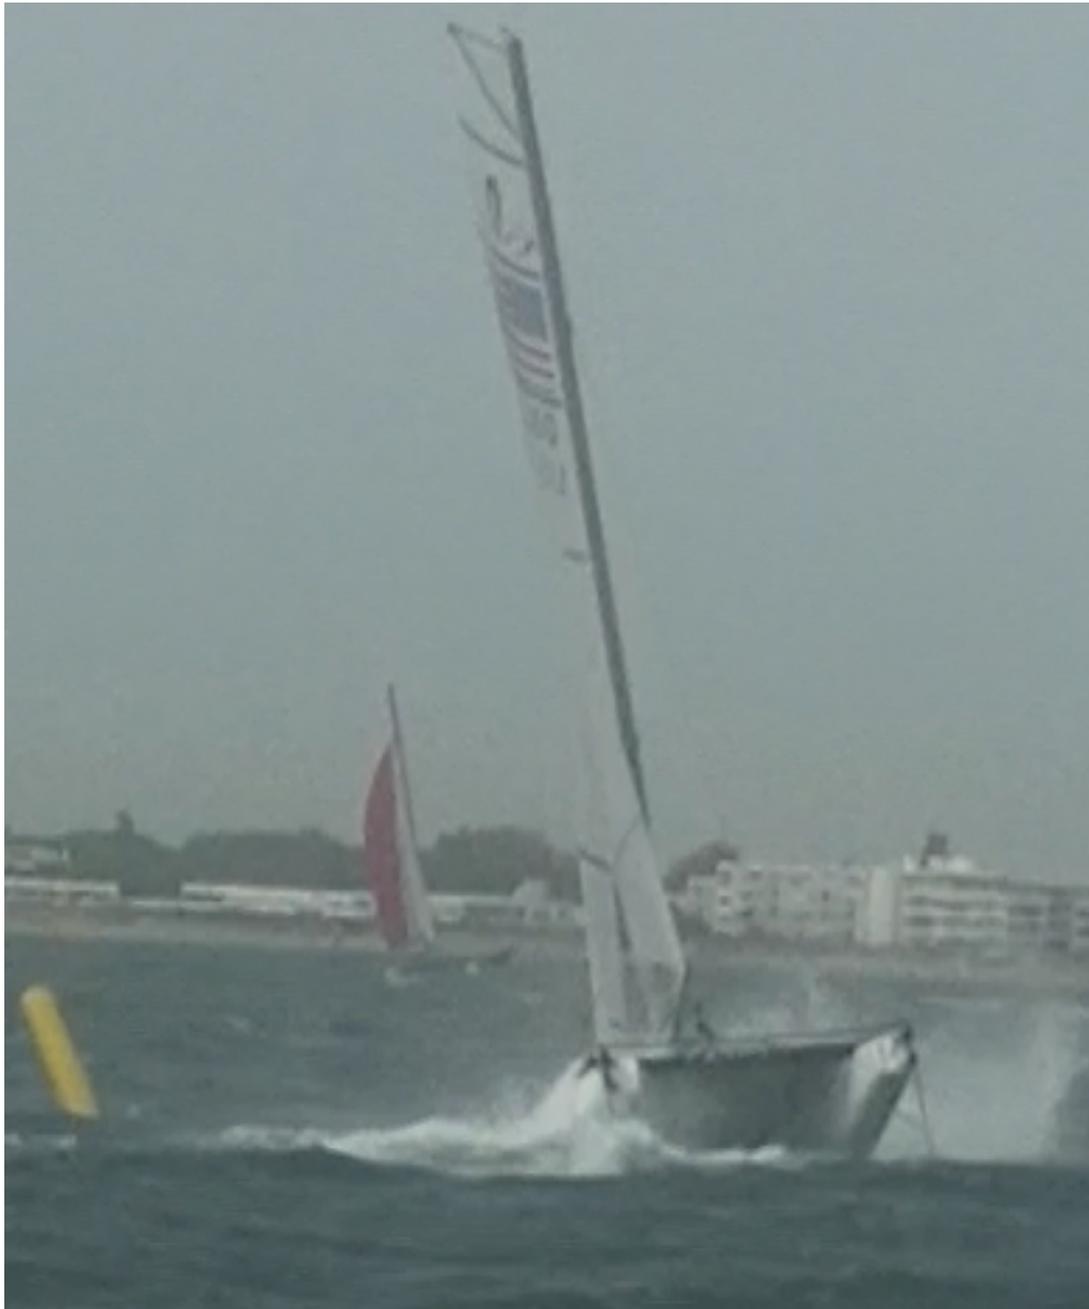
Figure D5 - Sailors not seen, traveler up (0:54)

- i. Hull movement through the incident: The hull digs in the leeward hull and begins the pitchpole at 0:53 seconds and the sailors are in the water at the forestay by 0:54. We note that the traveler is holding the mainsheet close to centerline until 0:55 when it is shown to be down to leeward indicating that it is no longer being held. The mainsheet is never eased. At 0:56 the hulls are both in the air with daggerboards and rudders showing and the bows submerged near where we know both sailors have entered the water. The hull pivots away from the sailors on the leeward hulls bow and spins away and onto its side on the leeward hull as two boats pass. By 0:58 the hull is seen on its side with both sailors near the bow, on the top side of the hull and away from the daggerboards. At 1:07 you can see a sailor holding one hand up out of the water, and at 1:19 the crew who is closest to the hull signals for help.

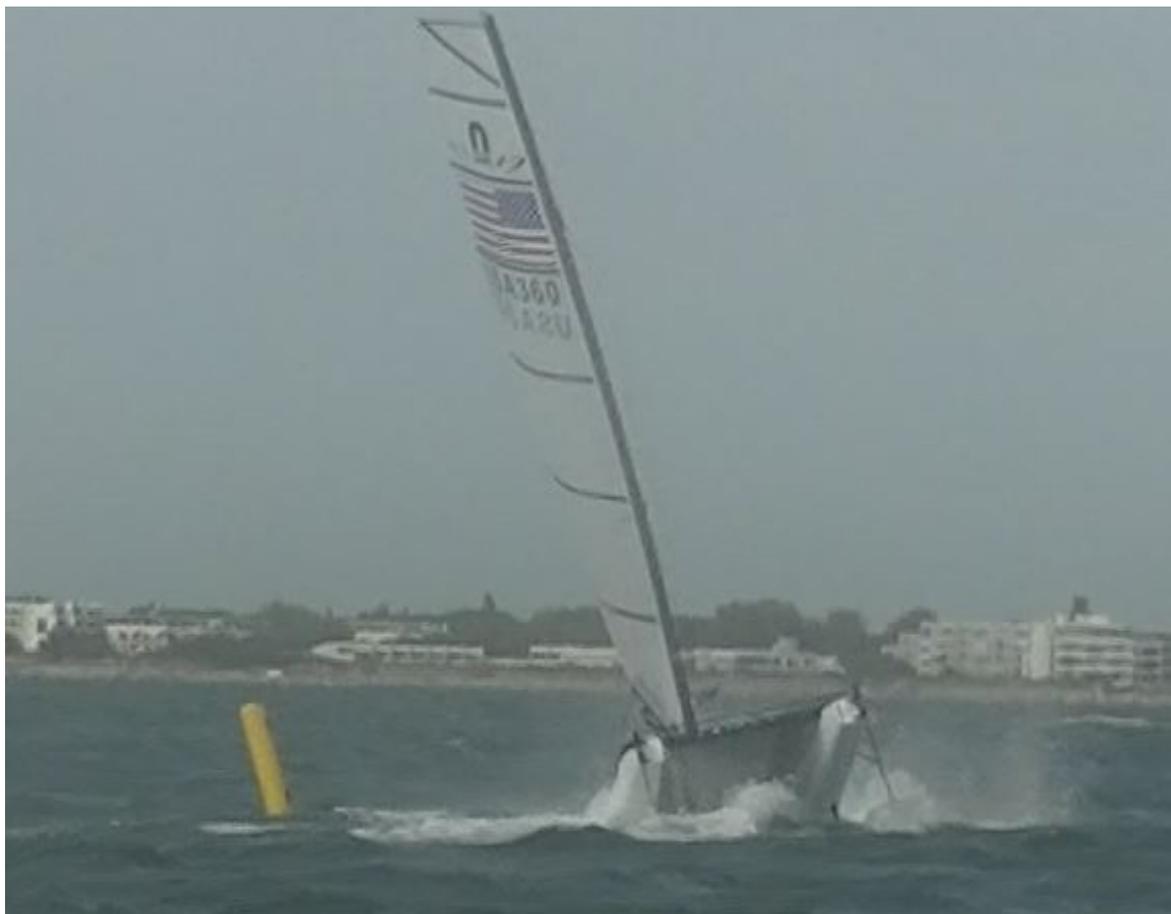
Figure D6 - Traveler Down (0:55)

- a. This section offers a progression of "how" the incident occurred to focus our view of the likely cause of the injury. The incident occurred because of a pitchpole when the boat suddenly went bow down and stopped, and the momentum carried the sailors forward at a high rate of speed. Pitchpoles are a characteristic of all catamaran's. The injured helm had the traveler control line wrapped around his hand. His recollections identify the traveler line as the mechanism of the amputation. The video cannot confirm this directly from its angle of view, because the sailors are not visible. However, the video does show the traveler control holding the mainsheet car close to centerline while the sailors are being thrown forward, and falling to leeward after we know that the sailors are in the water. The mainsheet itself appears to remain

cleated throughout the capsize. There is a possibility that the helm's hand could have made contact with the trapeze line of the crew as he was flung outside of her position with his hands flung out from his sides. Either way, there is not conclusive video evidence to support an exact determination of cause. We are certain the sailor was not in contact with the boat's appendages during the violent portion of the capsize when there was the possibility of energy being present to cause this extensive an injury.

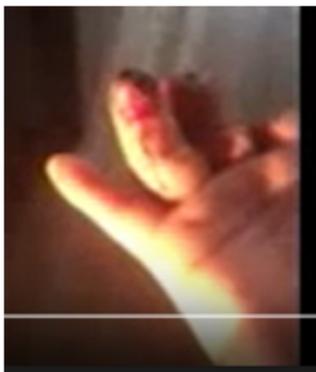
Figure D10 - Image of Right Hand After Amputation

- b. The helmsman describes no other injuries or muscle soreness after the incident.
 - c. The medical report is limited to a brief description of the cleansing of the wounds. In follow up examinations approximately one week later the helmsman reports that he discovered that his ring finger had been pinned and splinted as if broken. The skin on the ring finger between that finger and the small finger was badly abraded. Photos are included in Appendix D.

These photos are approximately 3 weeks post injury. Note large abraded area of the ring finger. This finger was pinned By the Emergency Room Dr. Indicating that the finger was Broken during the accident.

- c. Personal Safety Equipment – Sailors should wear gloves that protect against cutting by thin lines and wire under load. These are commercially available at low cost. The standard these types of gloves are tested is based on cutting with a straight edge. There are no protection standards that apply to wrapping lines around a hand.
