WORLD SAILING INVESTIGATION REPORT NACRA 17 INCIDENT

Prepared by: Kowalyshyn, Dina
Equipment Committee Chair

REVIEW OF NACRA 17 CLASS INCIDENT WITH SEVERE INJURY TO HAND

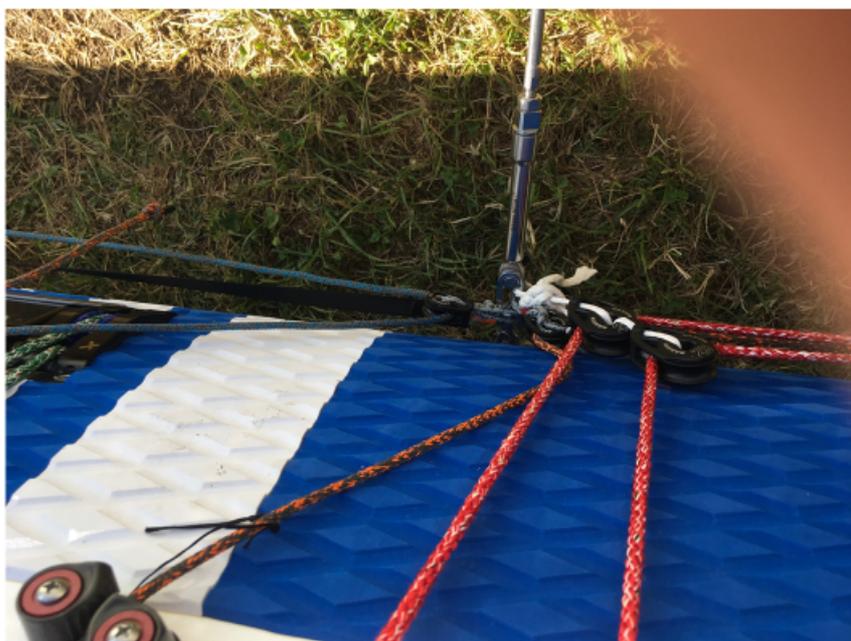
- iii. Possible impact points are the trapeze lines and the forward stays. The video shows that during this violent part of the accident the sailors are well clear of the hull and its appendages. In examination of the boats design features, rigging and outfit during this accident investigation it was noted that the lines and wires are thin and under load, and can cause cutting in a high impact accident.

Deck with grip padding and cleats, padeyes.
Terminals for attachments of shrouds and trapeze

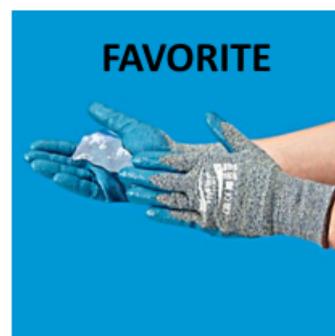
Heavy Duty 11-501 – EN 388 Level 4, ASNI Level 4. Ultra durable Kevlar® blend. Foam nitrile coating for secure grip.
\$19 per pair

- c. Personal Safety Equipment – Sailors should wear gloves that protect against cutting by thin lines and wire under load. These are commercially available at low cost. The standard these types of gloves are tested is based on cutting with a straight edge. There are no protection standards that apply to wrapping lines around a hand.
